Aircraft Structures Technical Memorandum 506

A REVIEW OF AUSTRALIAN AND NEW ZEALAND INVESTIGATIONS ON AERONAUTICAL FATIGUE DURING THE PERIOD APRIL 1987 TO MARCH 1989 (U)

This document was prepared for presentation to the 21st Conference of the International Committee on Aeronautical Fatigue scheduled to be held in Jerusalem, Israel, on June 19 and 20, 1989.

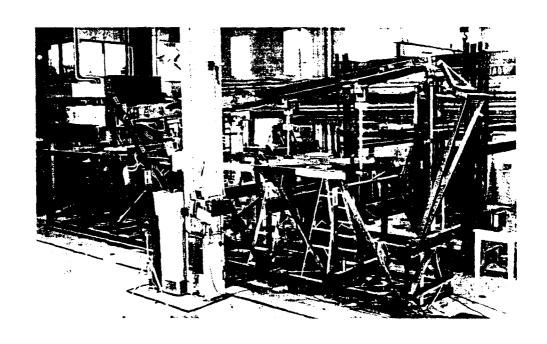
FIG. 2 F-111 WING WITH BORON/EPOXY DOUBLERS UNDER STATIC TEST (80% POSITIVE PROOF LOAD)

used in the standard cold proof load test (CPLT) to which all f-111's are regularly subjected in a rig designed by Hawker de Havilland, Victoria (Fig. 2). Because the test wing was one salvaged from a crashed aircraft, and to which "boiler-plate" repairs had been made, the strain survey was conducted at 40% of the proof loads: however, the wing with doublers was subsequently satisfactorily tested to 100% of the proof loads under ambient conditions. In an attempt to simulate CPLT conditions as far as the doublers were concerned, the WPF was then enclosed in a chamber and cooled to -40°C. The wing was satisfactorily tested to 100% proof down-load and then to 98% proof up-load; at that stage the test wing failed in the area of a boiler-plate repair.

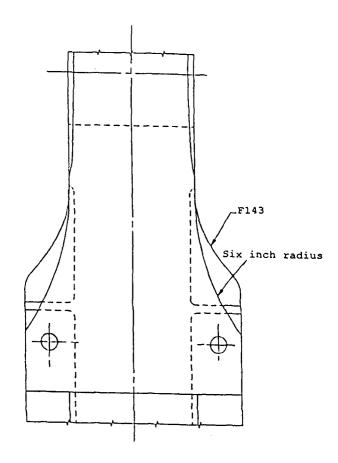
FIG. 7 F/A-18 BULKHEAD FILLET PROFILES

These bulkheads on the first 30 aircraft of the Australian fleet differ from those in later aircraft. The flange fillet profiles, Fig. 7, of the earlier bulkheads are such that their fatigue lives might be inadequate. It is intended that these early bulkheads be modified to conform to the later design at about 2000 flying hours (one third of required life). A fatigue test was required to prove that these aircraft would be safe until then. While similar tests have been carried out by Northrop, a bulkhead with this fillet profile was not included. Further, the Northrop tests excluded the longeron recess fillet so the ARL test is to validate this and other critical areas to the full required life.

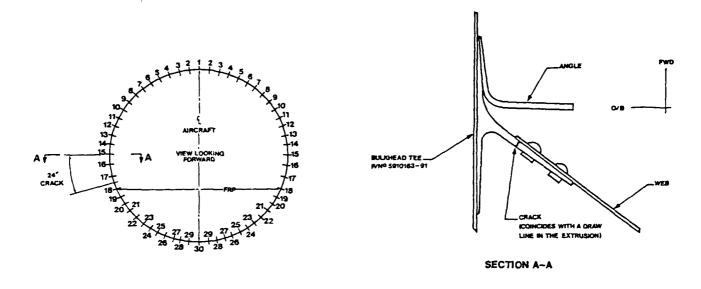
FIG. 9 DOUGLAS DC-9 REAR PRESSURE BULKHEAD ATTACHMENT

A massive crack has recently been discovered in the rear pressure bulkhead in an Australian registered DC9-30 aeroplane. The defect consists of a 24-inch circumferential crack in the stem of the T to which the bulkhead web attaches. The general arrangement is shown in Fig. 9, and part of the fracture surface in Fig. 10. The aircraft had achieved 36079 cycles, 40336 hours. Laboratory examination [8] has confirmed the crack as multiple origin fatigue. The initiation sites are on the forward face, and extend over most of the crack length. The crack had entered an unstable growth phase and complete failure - probably catastrophic - was imminent.

The crack was detected visually from the aft tace during a scheduled D check. However, it is alarming that cracking of such an extent was present at the initial inspection threshold. It is also noted that, since the cracks initiate on the forward face under the web, they are not visually detectable until they penetrate through the thickness, even though extensive multiple site damage may be present.

The aircraft operator has noted that through-cracks of smaller circumferential length would also be difficult to detect, since even this large crack was not obvious. Access is difficult and requires removal of APU and air conditioning equipment, and thorough cleaning to remove insulation, sealant etc.

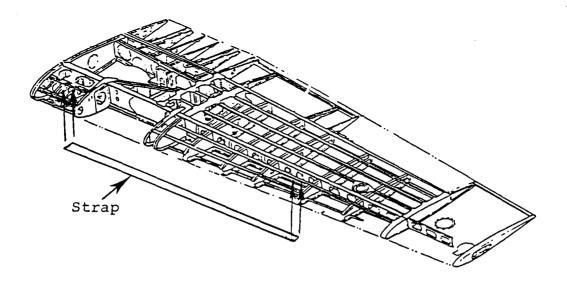
FIG. 11 CESSNA SERIES 400 SPAR REINFORCEMENT STRAP

CAA Airworthiness Directive Cessna 400/40, Amendment 8, has reduced the safe life of all series 400 (402B, 421B, 402C, 421C) wing spars. To comply with the AD, aircraft life extension must be achieved by spar replacement.

As an alternative to spar replacement, HDH has designed an external fail-safe strap for critical regions of the lower spar cap such that in the event of spar failure, the strap will carry subsequent wing loads: the design has CAA approval. There are some detail differences between straps for various models within the series to accommodate various engine installations, spar cross sections and service loadings.

The straps (up to four laminates) are riveted through the lower spar cap at existing rivet positions. Prior to installation, and with these rivets removed, the spar cap is inspected for cracks with an Eddy-current detector using a technique which scans each (vacant) hole. If cracks are discovered, the modification is not proceeded with.

The strap is designed using Damage Tolerance philosophy. An initial (manufacturing) flaw is assumed to exist and the rate of growth is estimated using in-flight measured stresses. To assure safety, these rates are then assumed to accelerate by a factor of 3.5 to account for variability. Inspection intervals are then set using this accelerated growth rate curve and from established statistical data such that there is a 95% probability of detection. By this approach no safe-life is guaranteed but the wing is serviceable subject to a clean inspection result.

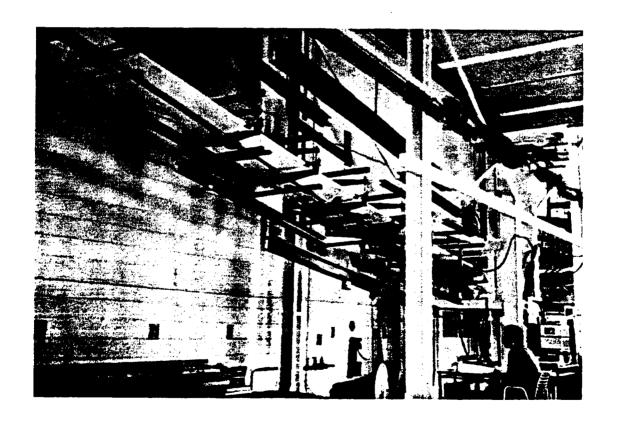
FIG. 12 JANUS GLIDER WING FATIGUE TEST

No major structural problems have been found so far. The most recent incident was the failure of a whifile tree link (steel cable) during the 6000 hour 6g (5.9g achieved) limit load application. The safety link held and no other damage was incurred; all similar links have since been replaced as a precaution.

There have been numerous instances of skin cracking in the starboard (repaired) wing which all appear to be associated either with repairs or with damage incurred in the aircraft crash, some of which was deliberately left unrepaired and some of which was undetected. These cracks, most of which would be repaired immediately if found in service, do not measurably affect the stiffness, mode shapes or frequencies and are thus not considered to be significant structurally. Some have been repaired, others are being monitored.

One detect has been found in the port (factory supplied) wing, involving skin cracking at the lower surface skin/root rib/spar junction. This crack was initially detected and repaired early in the test. Recent failure of the associated strain gauges, and visual indications, now indicate failure of the repair. This is being monitored.

Static deflection checks have shown that the wing stiffness is unchanged. Vibration checks have shown that with one exception the modes and frequencies are also unchanged. The exception is a 3% drop in the frequency of the first antisymmetric mode. This mode involves rotation in the centre section joint and is most likely the result of wear and/or lubrication changes in the wing attachment pin and socket joints. This is being monitored at each major inspection. The test rig is shown in Fig.12.

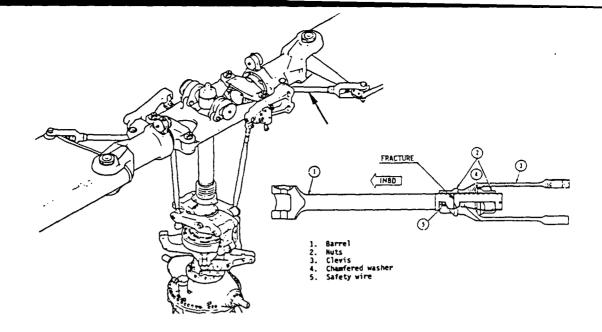
FIG. 13 BELL 214ST MAIN ROTOR HEAD AND DRAG BRACE

When the wreck was recovered after 6 weeks in 30 fathoms, it was found that one main rotor blade drag brace had failed in fatigue [10]. The failure had occurred in the 1.25-inch diameter threaded portion of the rod, under the innermost of two nuts which clamp the blade attachment yoke at the outer end of the brace. The assembly is shown in Fig. 13, the broken drag brace and the fracture surface after cleaning in Fig. 14.

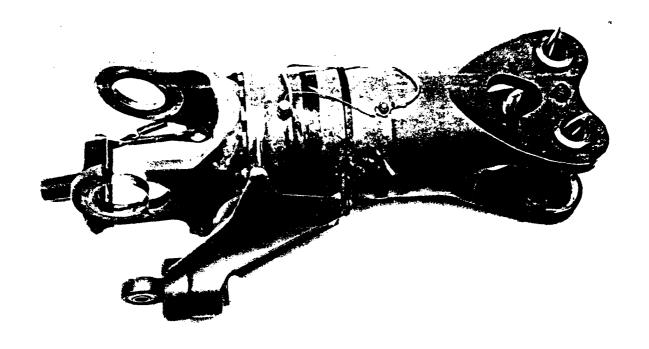
FIG. 15 AEROSPATIALE SA330J PUMA MAIN ROTOR SPINDLE FAILURE

In May 1987 an Australian registered Aerospatiale SA330J Puma helicopter experienced a failure of one of the two flapping hinge lugs on one main rotor blade spindle during an off-shore flight with 17 people on board. The resulting out-of-balance forces caused severe vibrations and control difficulties; however, the crew were able to descend and hover-taxi to a barge where the machine was landed safely.

Laboratory examination [11] of the fracture surfaces revealed the presence of fatigue. The fatigue cracking had initiated in an area damaged by fretting on the inner surface of the lug. This fretting resulted from the inner bearing race of the flapping hinge pin assembly contacting the lug face. The offending spindle is shown in Figs. 15 and 16; note the bend in the remaining lug.

Measurement of the crack propagation rate showed that one lug fracture propagated, from a crack depth of 3.4mm to complete failure, in approximately 180 start/stop cycles. Taking the average start up/shut down time of 1 hour 15 minutes for this operation, it was estimated that this occurred over a period of 225 flight hours and the crack in the lower section of the lug propagated from 4.3mm to failure in 100 cycles i.e. 125 hours. The time since last overhaul was reported to be 989 hours. The head had also been removed for minor repairs 398 hours prior to failure, but had not been disassembled at that time.

The investigation also brought to light the fact that the maintenance manual required disassembly and inspection of the lugs for fretting and cracking at 800 hours. This inspection had been overlooked for this aircraft, partly because the requirement was not highlighted as a safety-of-flight critical inspection (there had been previous similar failures overseas); and also because the operator believed that all heads in his fleet had been factory modified to a later configuration which incorporated an anti-fretting modification.
